# Manhole Inspection Summary

Manhole # S45WW\_010MH

Insp Date: **2/9/07 9:05 AM**

**Location** Address: **1829 31ST ST**

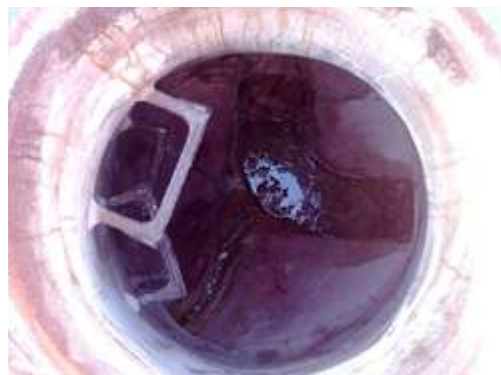
Top View

Frame leaks. Channel debris.

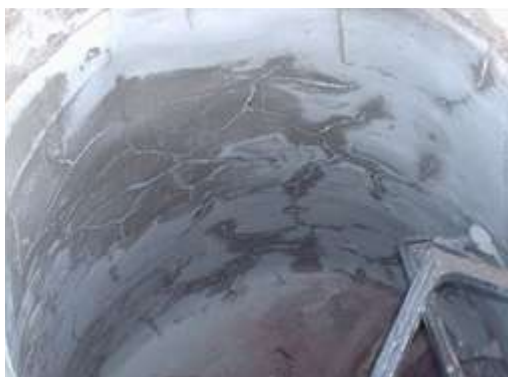
Defect

Corbel and Barrel infiltration.

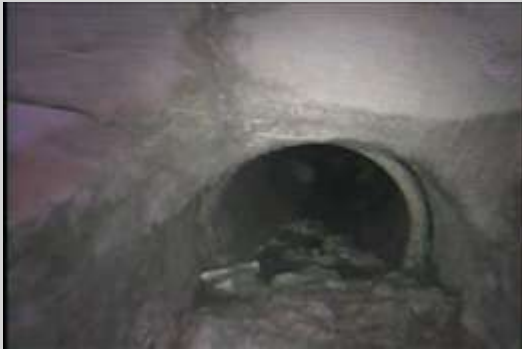
### 12 in. Circular Gravity Sewer Pipe Out @ 12 O'Clock

Invert Depth: **6.69** (ft.) Flow Characteristics: **Slow**

Deposits: ☐ None ☒ **Mud** ☐ Sludge ☒ **Debris** ☐ Grease

Silt Depth: **2** (in.) Deposits Extent: **Light**

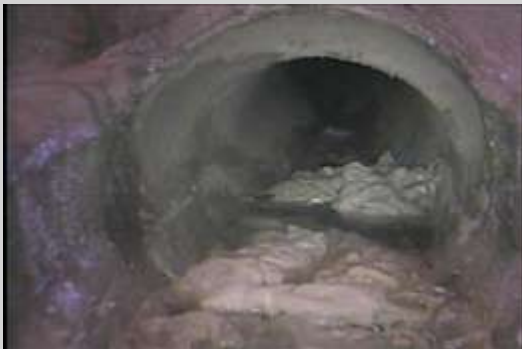
### 8 in. Circular Gravity Sewer Pipe In @ 3 O'Clock

Invert Depth: **6.49** (ft.) Flow Characteristics: **Slow**

Deposits: ☐ None ☒ **Mud** ☐ Sludge ☒ **Debris** ☐ Grease

Silt Depth: **1** (in.) Deposits Extent: **Light**

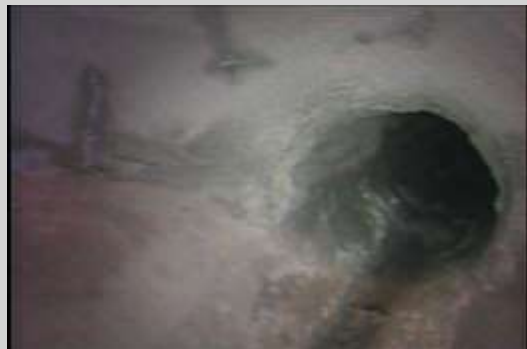
6 in. Circular Gravity Sewer

Connects To: **House connection / Service line**
